| Summary | Updating Encoder Software Via EPROM Chip | | | | |
| Products Affected | System 3 Controllers with a mobile address lower than 3500 | | | | |

## Wireless software eprom V36-01.01

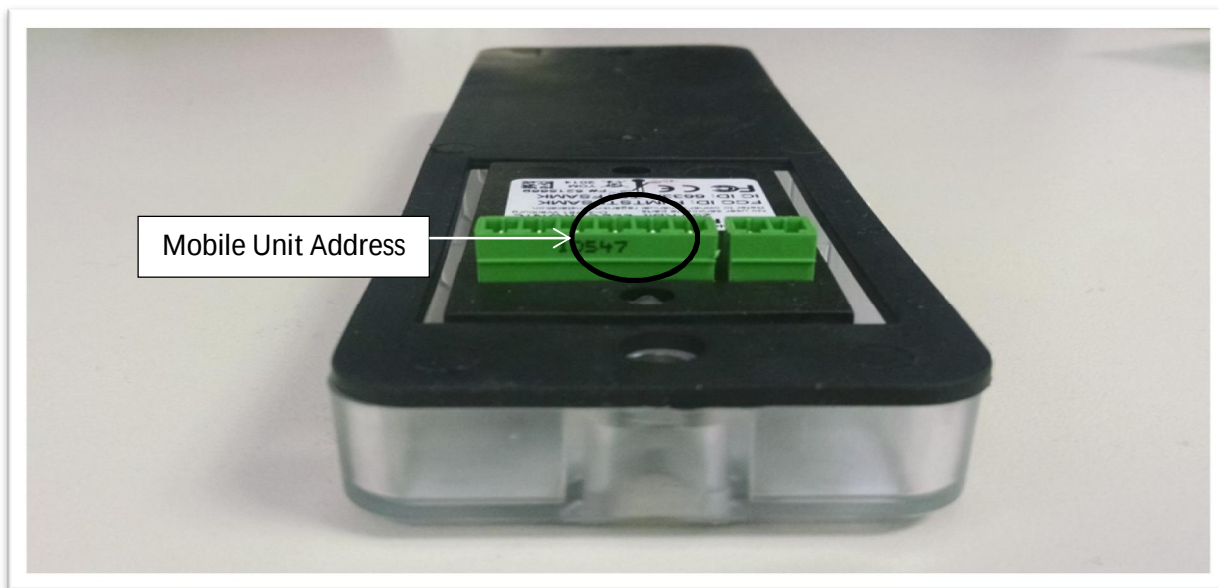
The new Mobile Unit Address is located on the green part of the plug in base. It will be 4-5 characters
