| Summary | Replacing Car Wash Motors with new Ovitor Motor with curved black cover. | | | | |
| Products Affected | Car Wash doors models WS3 & Clear Shield. | | | | |
| Author | Randy Meyer, RevA M. Burzlaff | Issue Date | 1/13/2011 | Status | Active |

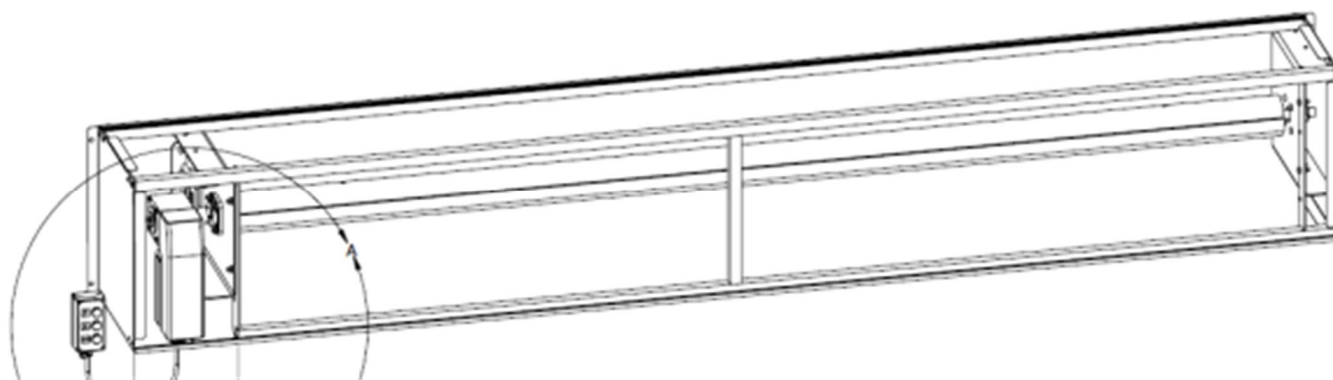
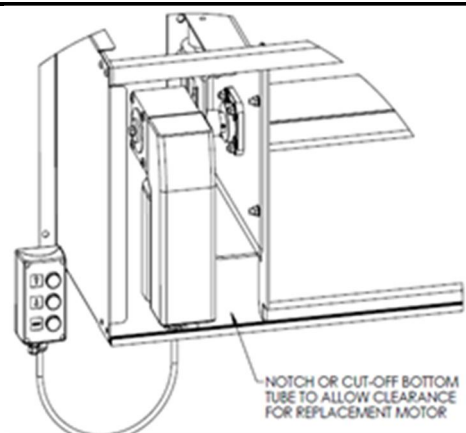
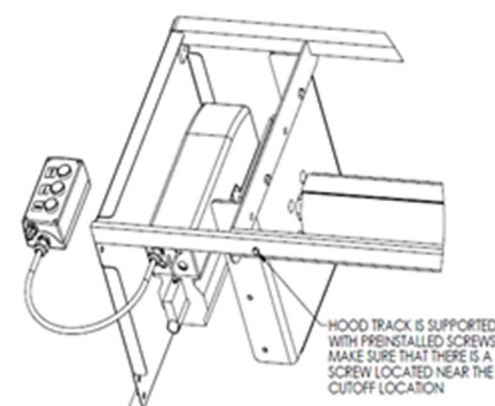
The motor manufacturer (Ovitor) has changed the design of the cover for the Ovitor motors from the original shipped with the door. The newly designed cover allows more space for routing the control wiring. This new design prevents interference with the internal up and down push buttons inside the cover that created problems in the previous design.

Since the cover has been redesigned and is larger, a modification must be completed to the door hood (cover). The piece of tube steel along the bottom of the front cover must be removed or notched out to accommodate the new Ovitor motor and cover. This can be performed using a sawz-all or grinder. The tube steel is bolted to the drum roll bracket therefore; the tube is supported and will not sag or swing free in the opening. The drawings below illustrate a left hand drive; right hand drive is the same condition. See the drawings below.
