| Summary | Plexline Upgrade | | | |
| Products Affected | Plexline | | | |
| Author | Jeff Miller | Issue Date | 2-7-14 | Status Active |

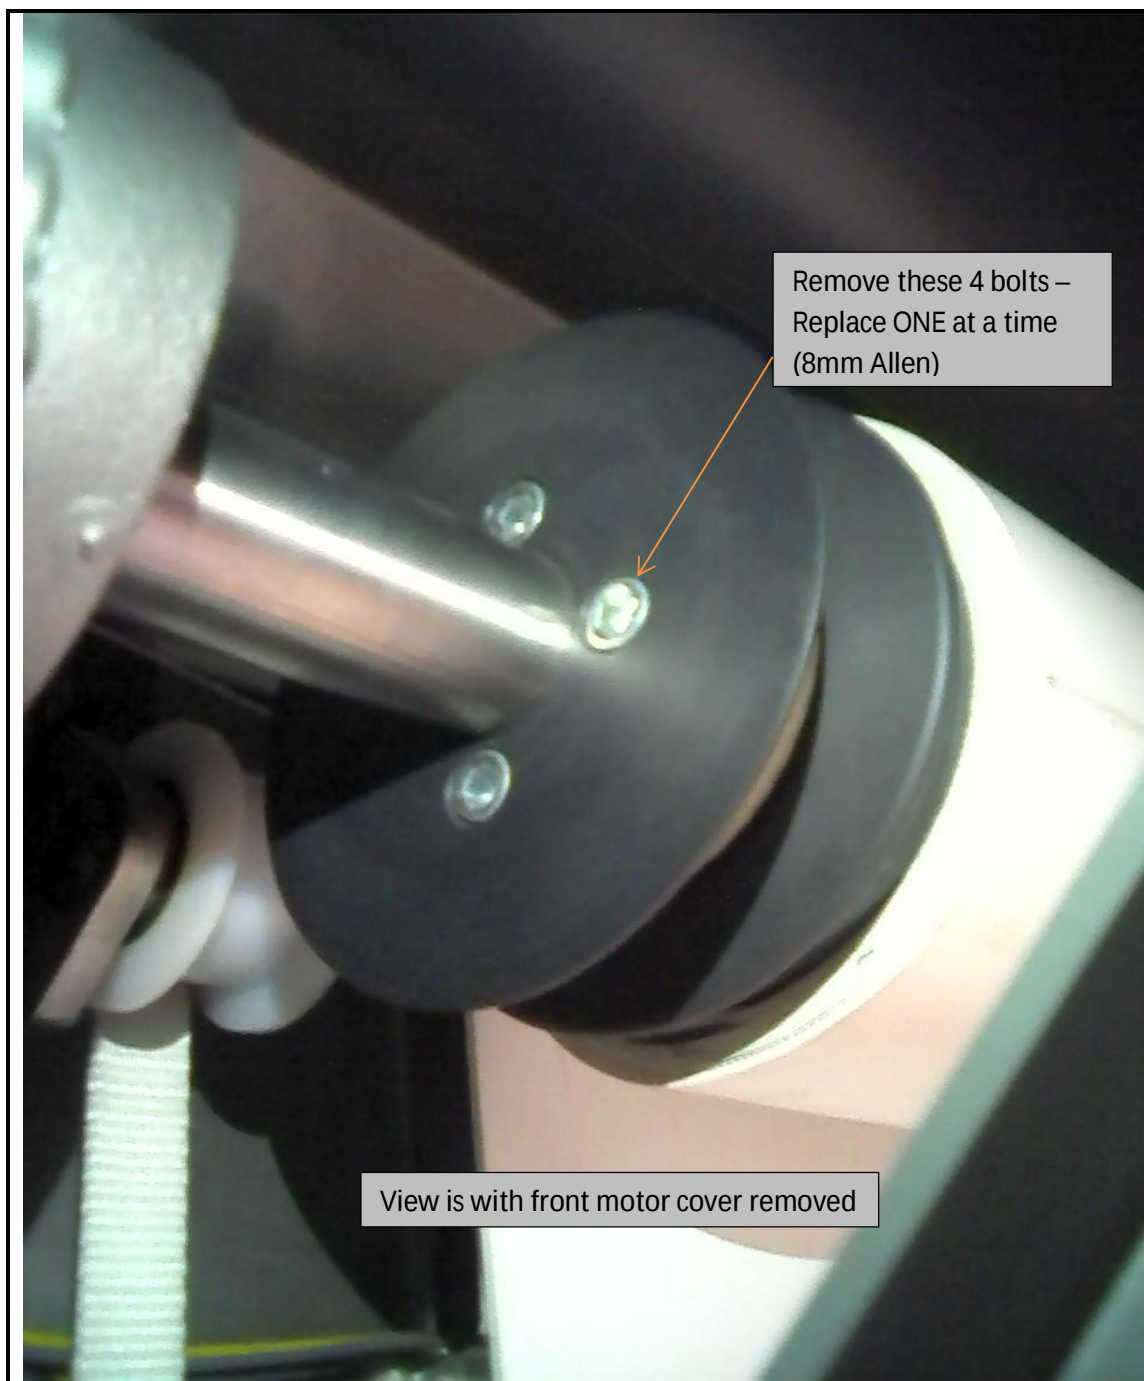
Remove these 4 bolts –  
Replace ONE at a time  
(8mm Allen)

View is with front motor cover removed

**ONE** at time, remove each bolt (if any) and replace it with the supplied hardware, Loctite and tighten. It may be necessary to rotate the drum in emergency jog slowly to get at all 4 of the bolts. If there is no pulley, add the new bolts to the tapped holes on the drum and tighten them.
