| Summary | Add Blue loctite to motor mounting bolt on Wyndstar MT | | | |
| Products Affected | Wyndstar MT, Carwash | | | |
| Author | Randy Meyer | Issue Date | 4-10-13 | Status Active |

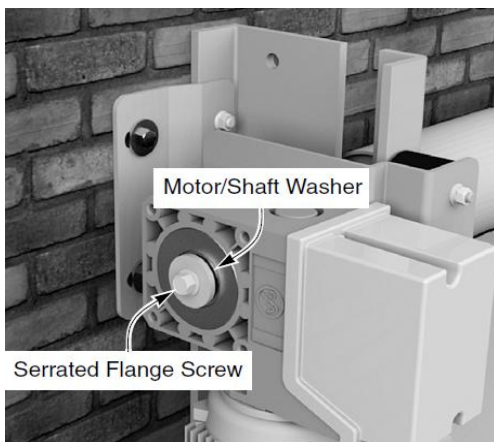
Figure 1

The Wyndstar MT carwash model door has experienced some motor bolts loosening after installation. See figure 1.
