| Summary | Securing sliding vision panels | | | | |
| Products Affected | All spiral doors with Lexan Keder Vision Slats | | | | |
| Author | Mike Burzlaff | Issue Date | 7/22/2015 | Status | Active |

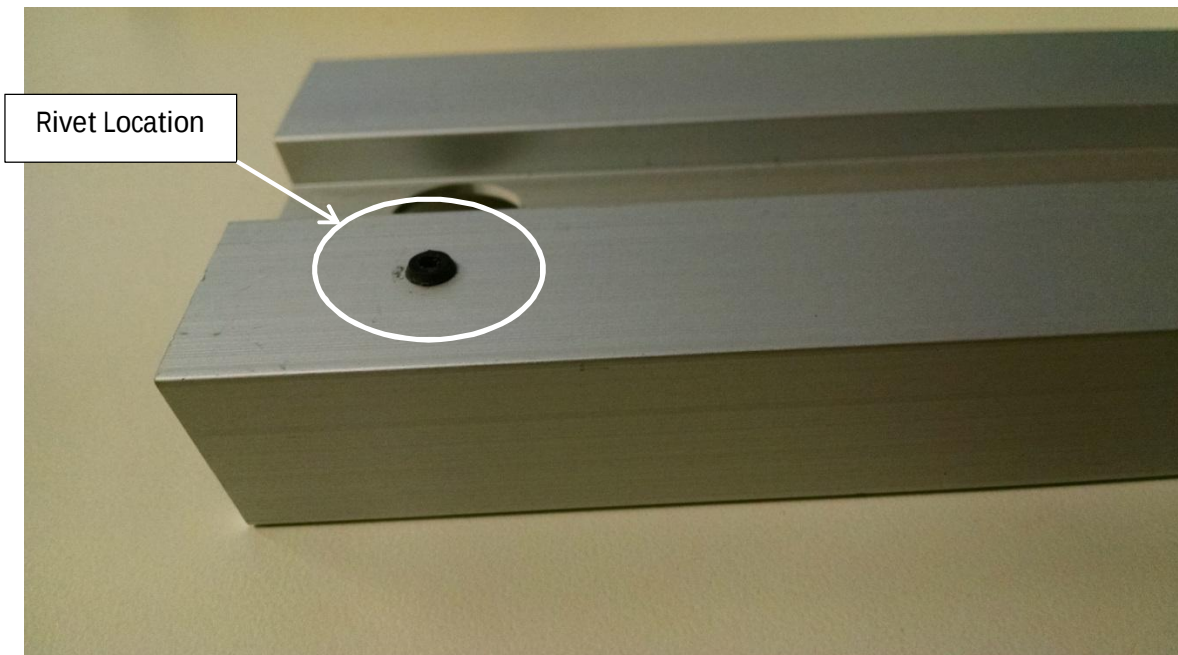
Figure 1

Lexan vision slats have been found to slide out of position for 2 primary reasons. The original design utilized a plastic rivet on the left hand hinge assemble to hold the slats into position. It has been found that this plastic fails and allows the vision panels to move during door operation. (See Figure 1)

- The rivets will now be replaced by a ½" #2 Phillips screw. (See Figure 5 & 6)
- The orientation of each slat will need to be confirmed and corrected if necessary.

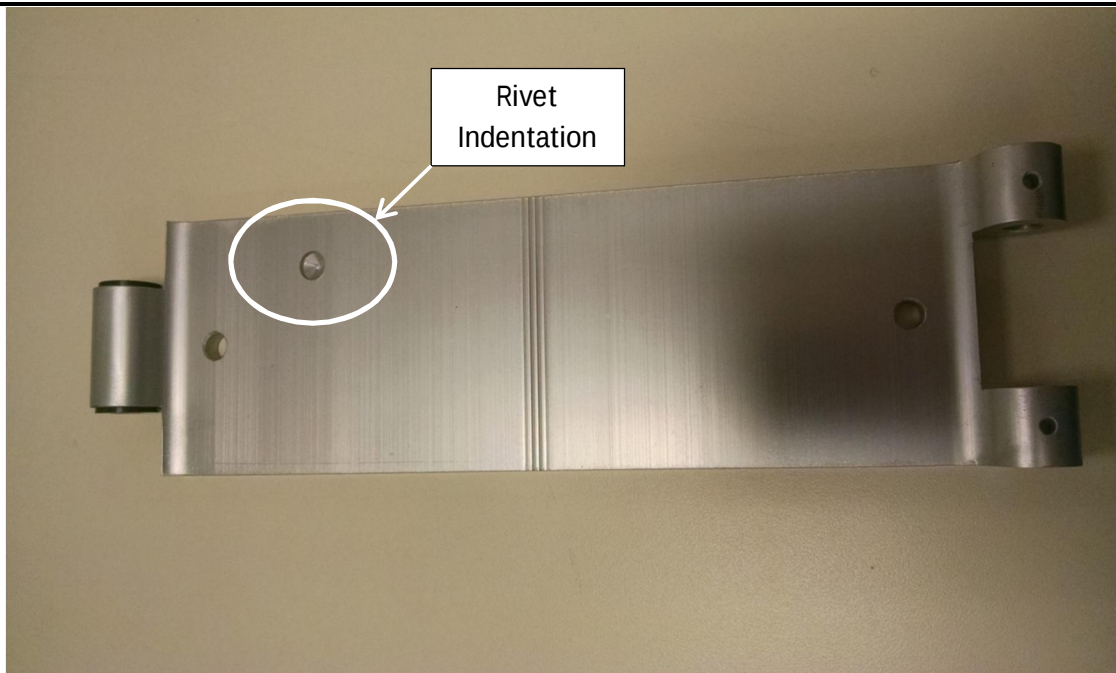
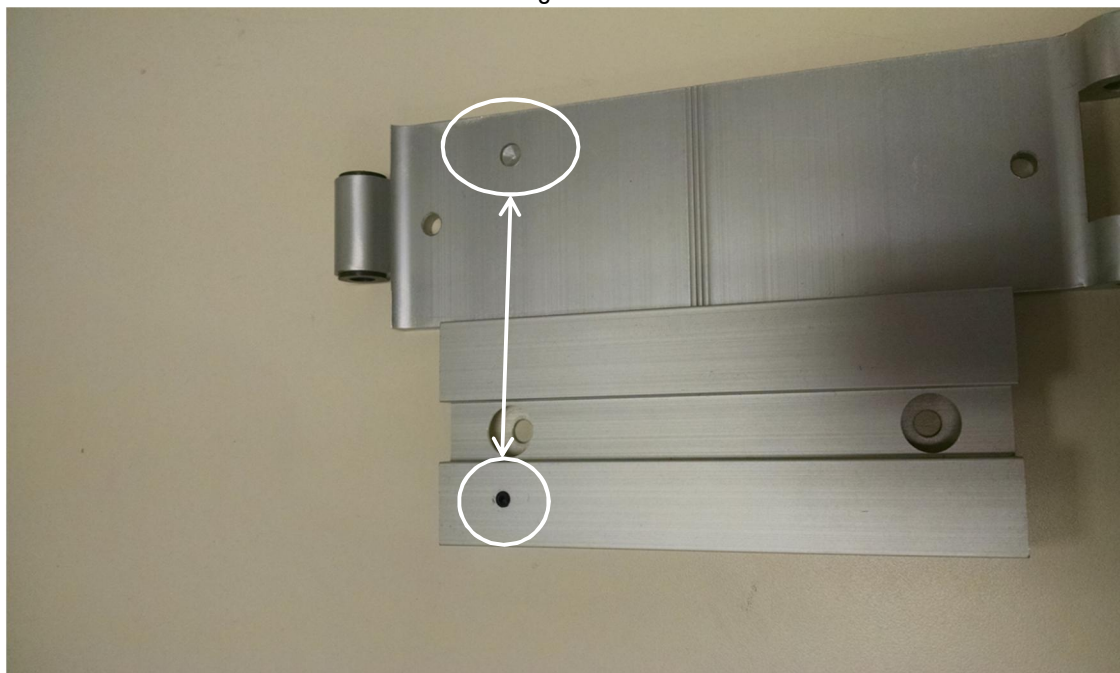
It has also been found that when the slats are oriented 180° from their correct position the panels can slide. When assembled, all the rivets/screws should be on the left hand side of the door. This allows for the rivet to mate with the indentation on the left hand hinge. (See Figures 2 & 3).

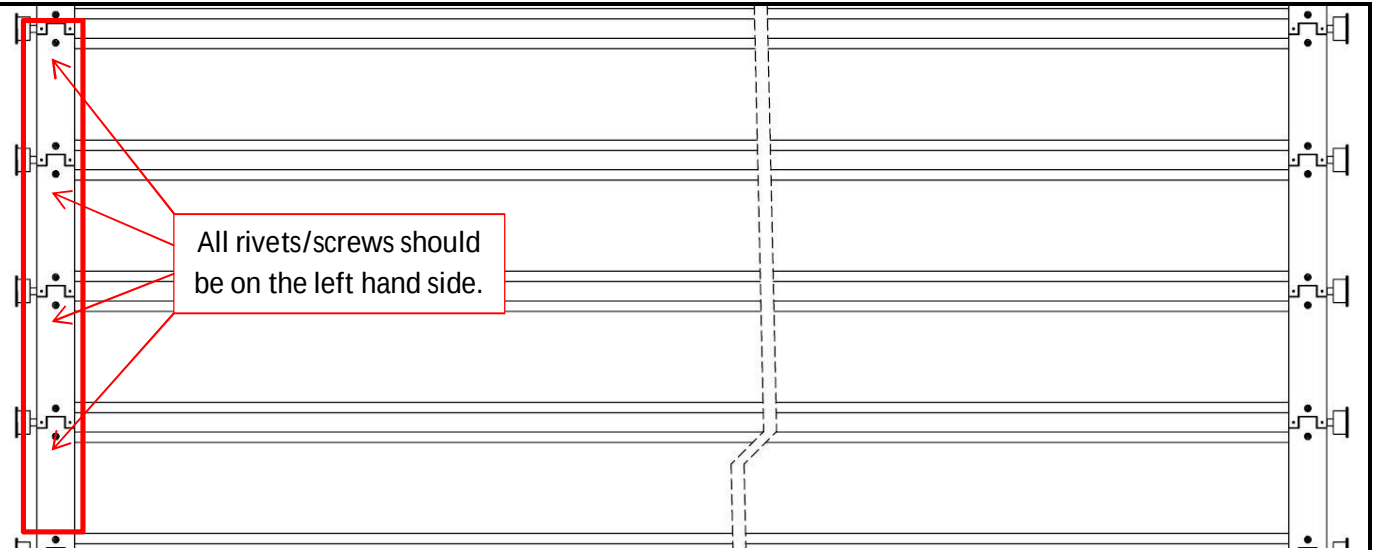
Figure 4

On occasion, some slats were assembled with the rivet on the lower right position instead of the upper left position. IE the slat was assembled 180° from the intended position. This also allowed the vision panels to move during door operation. (See Figure 4)
