| Summary | Replacing the wireless on a TSI Gen 2 | | | | |
| Products Affected | TSI Gen 2 | | | | |
| Author | Mike Burzlaff | Issue Date | 9/1/16 | Status | Active |

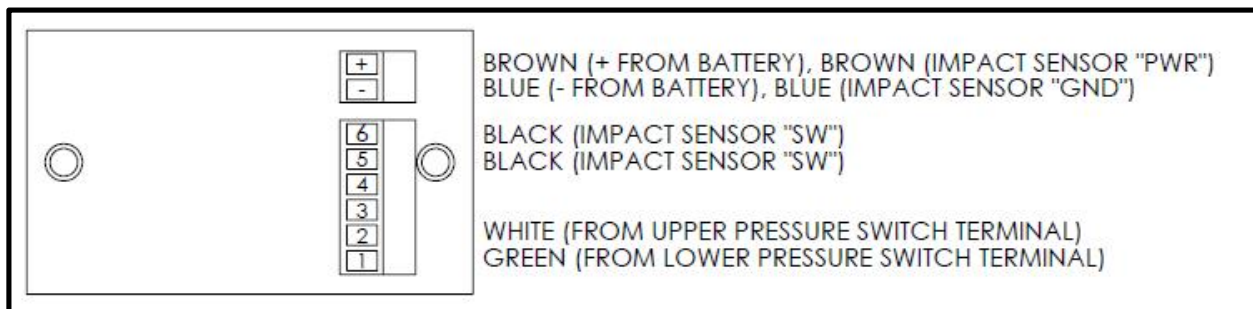
7. The new color code is as follows.
  - Red** is battery positive (+) The brown from the battery and brown from the impact sensor connect to the red wire.

- Black** is battery negative (-) The blue from the battery and blue from the impact sensor connect to the black wire.
  - Blue wires** are for the accelerometer connections. They connect to the black wires.

- Brown wires** are not used and must be capped individually.
  - White wires** are for the safety reversing edge. They connect to the green and white wires.

8. Connect the wires as described above with the new wire colors. The brown wires **MUST** be capped separately or a F822 fault will occur.
9. When the connections are completed, neatly place all wires back into the bottom bar. Remove the "Lock out/Tag out" and re-apply power to the controller. Press and hold the STOP/RESET button to clear any faults that may be displayed.
10. The new mobile address must be programmed into parameter (P.F07) The address is no longer imprinted on the unit. The mobile unit address is printed on the white sticker attached to the wires.
