| Summary | Replacement of the end tabs on the TSI Gen 2 | | | | |
| Products Affected | TSI Gen 2 | | | | |
| Author | M. Burzlaff | Issue Date | 5/21/18 | Status | Active |

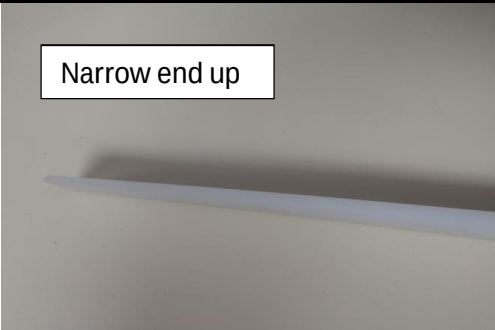
Narrow end up

Install the side column ramps into the center of the side column between the brush seals. The narrow end of the ramp is the top and the thicker end is the bottom. The bottom of the ramp should be at the bottom edge of the side column. Install the 3 tapered self-tapping mounting screws into the tapered pre-drilled holes. Do this on both side columns.

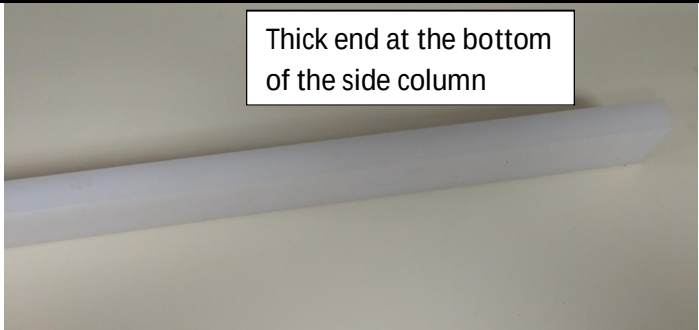
Thick end at the bottom  
of the side column

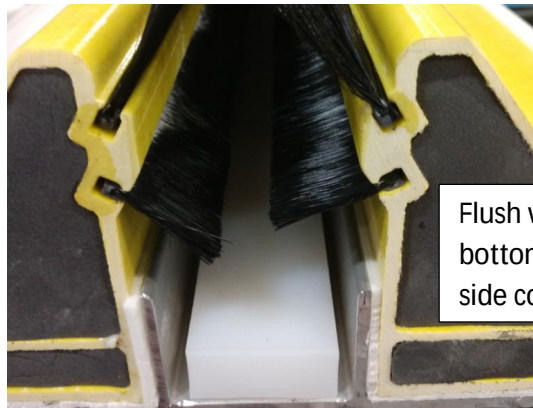
Flush with the  
bottom of the  
side column

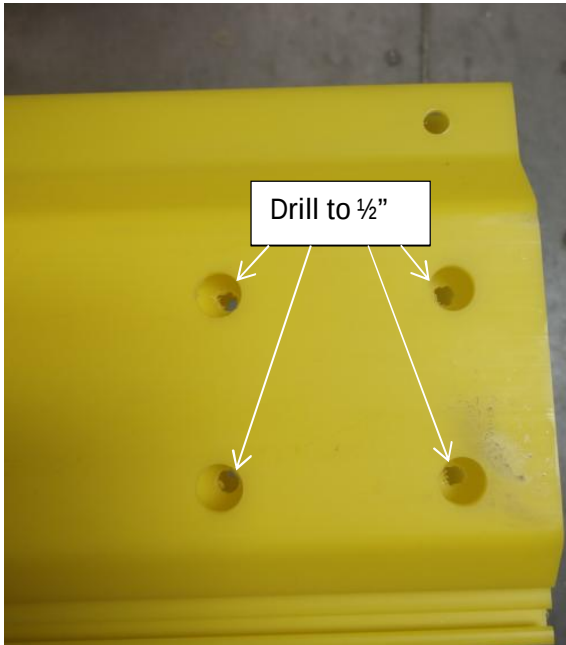
“Tapered” Face

Drill to  $\frac{1}{2}$ ”

Pull the bottom bar out of the guides to the inside of the door. Unbolt and remove the old end tabs from the bottom bar. The existing bottom bar holes will need to be made larger to fit the new bolts. On the “Tapered” face of the bottom bar which is the same face the wireless unit is mounted, the existing outer holes which had the black caps need to be drilled to  $\frac{1}{2}$ ”. The existing holes on the flat face of the bottom bar will need to be drilled to  $\frac{5}{16}$ ” to fit the new end tab hardware. Do this on both ends of the bottom bar.

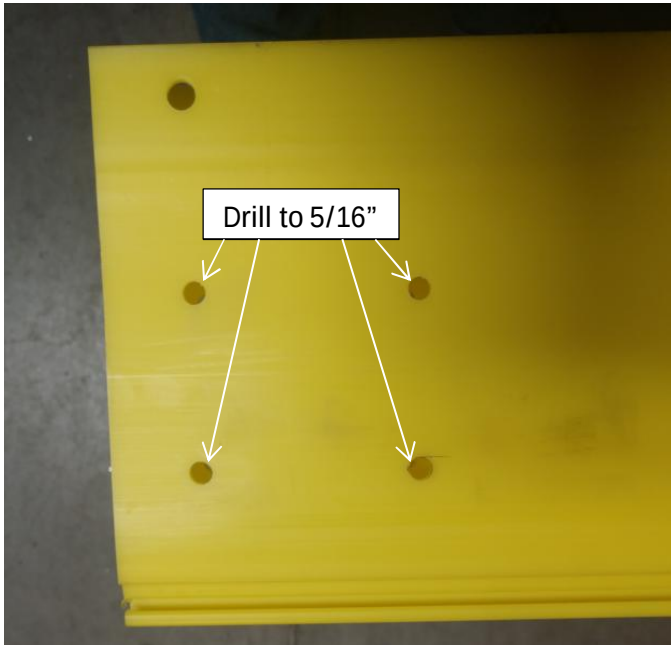
Flat Face

Drill to  $\frac{5}{16}$ ”
