| Summary | Replacing spring straps on drive side of Spiral LH (Low Head Room) L-Size (9-1/2") | | | | |
| Products Affected | Spiral LH (Low Head Room) L-Size (9-1/2") side columns. | | | | |

This bulletin describes the replacement procedure for the blue spring strap for the Spiral LH L-Size model doors for the drive side console.

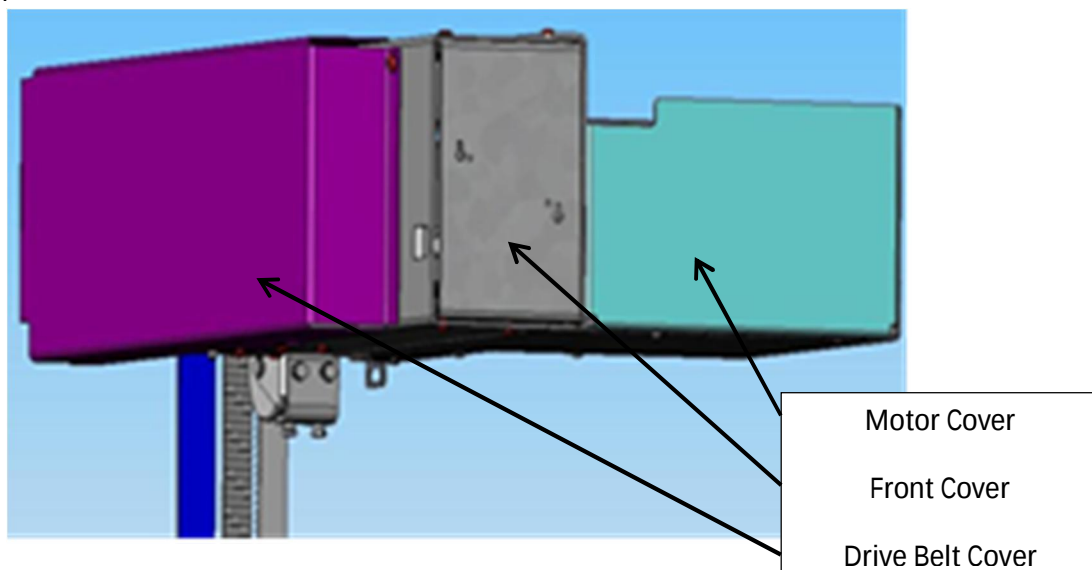
DRIVE SIDE ONLY

1. Remove the side column cover.

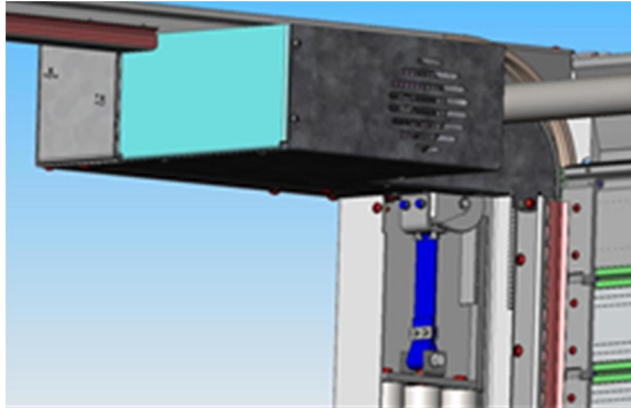
2. Remove the spring pack from the posts at the bottom of the side column.

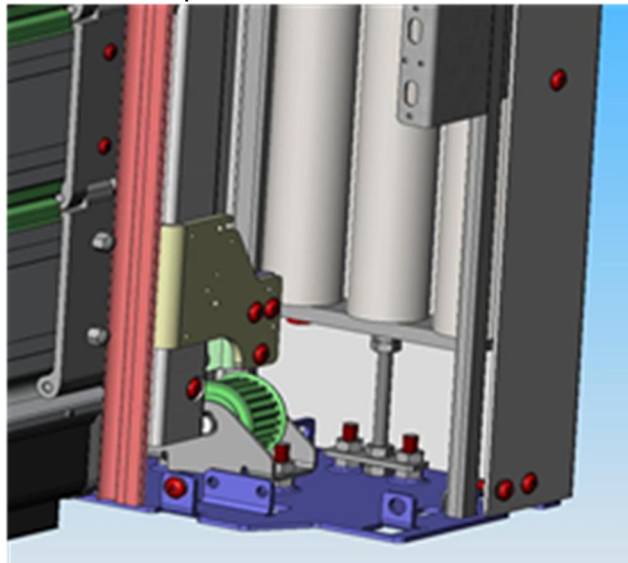
3. Remove the shoulder bolt that attaches the spring pack to the blue spring strap.

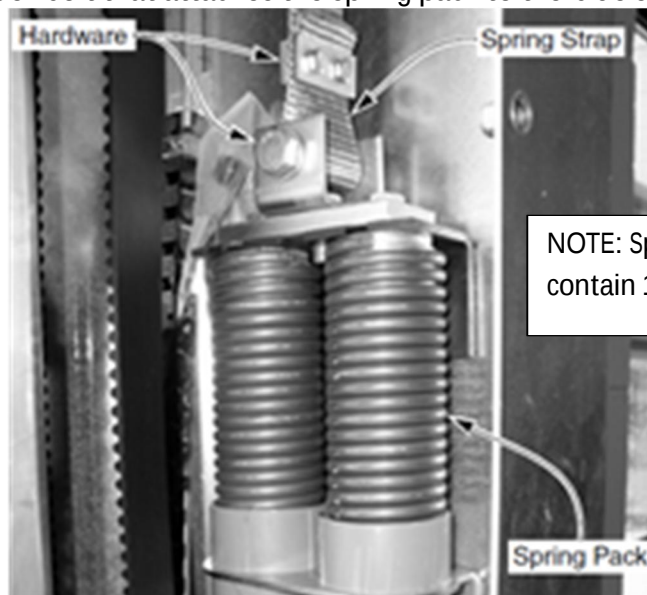
NOTE: Spring pack may contain 1-3 springs per pack.

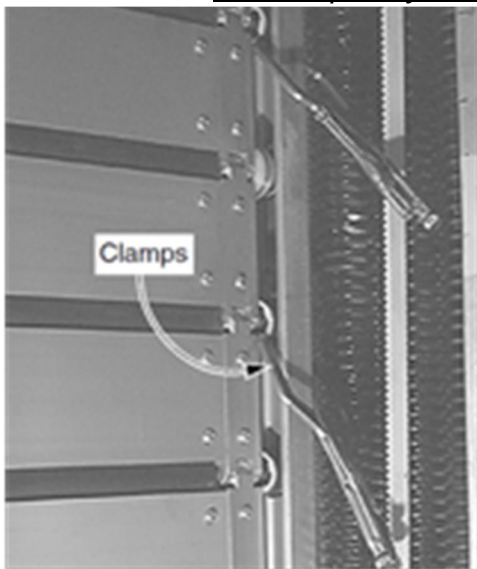
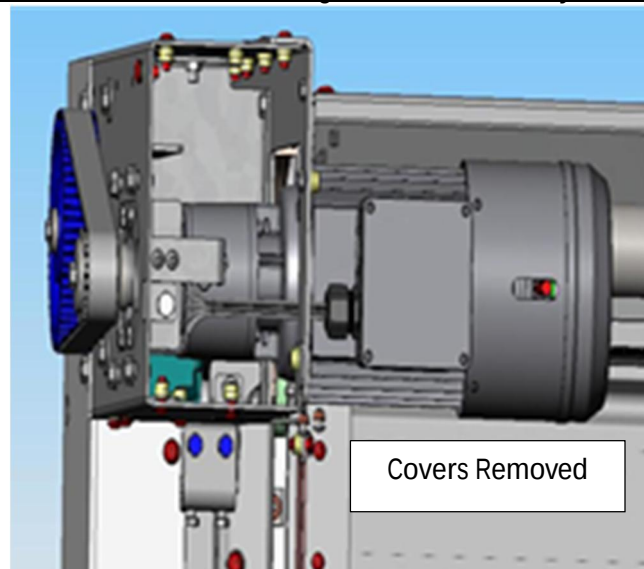
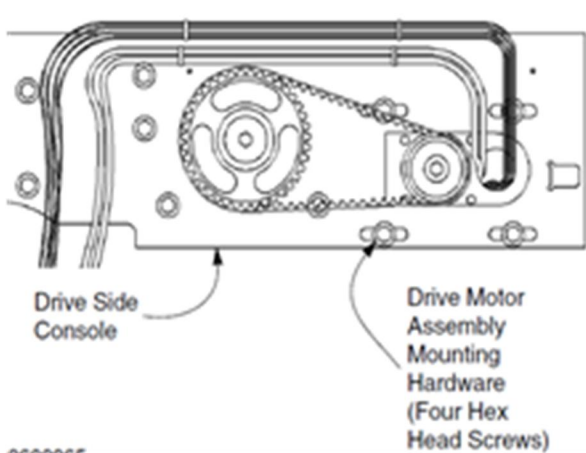
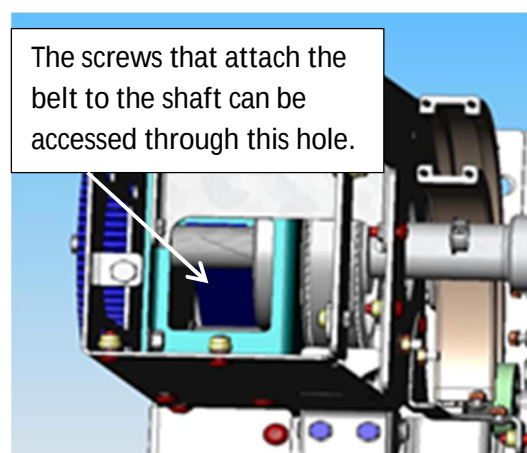
4. Remove the bracket that holds the springs in the side column (plastic sleeves).
5. Remove the spring pack from the side column.
6. Remove the spring strap clamps from the blue spring straps. These will be re-used on the replacement strap.
7. Remove the drive belt cover, front face cover and motor cover of the console. This will allow access to the straps clamped to the shaft. **NOTE:** The motor covers the access hole for the clamping plates for the spring strap. Therefore, the motor must be removed to replace the blue spring straps. **CAUTION:** WHEN THE DRIVE BELT IS REMOVED FROM THE MOTOR THERE IS NOTHING TO PREVENT THE DOOR FROM MOVING. CLAMP THE DOOR TO PREVENT MOVEMENT. **DO NOT** place your hands inside the console during movement at any time.

8. Remove the end of the strap on the shaft in the console. **NOTE:** Count the pre-wraps of strap on the shaft before removal. The same amount of pre-wraps will need to be placed for the replacement strap.
9. Install the replacement strap with the proper amount of pre-wraps. **IMPORTANT:** The pre-wraps must be tight and in alignment on the shaft. If you fail to align properly the strap may spiral off the shaft and cause premature wear to the replacement strap.
10. Drop the strap down into the side column.

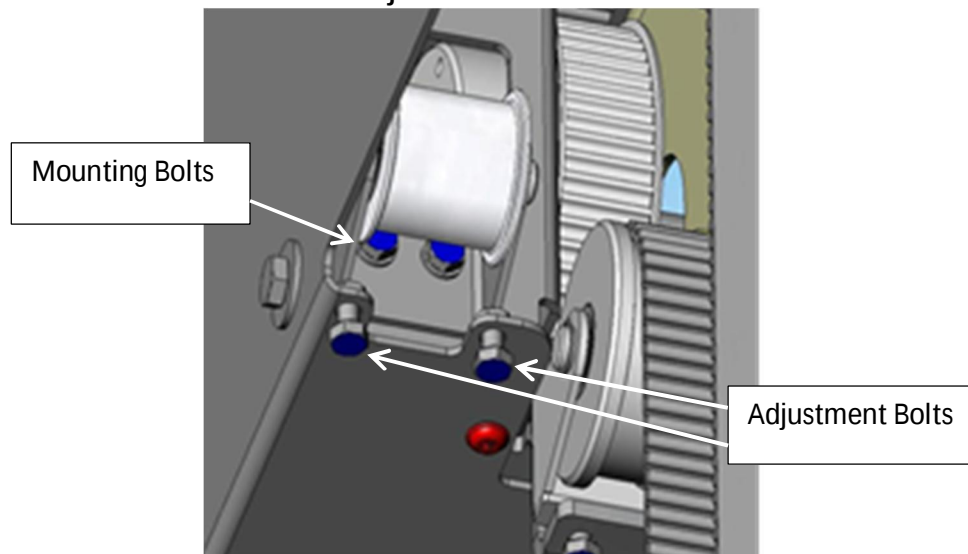
14. Turn power on to the door and test operation of the door.
15. During travel visually inspect the spring strap for proper travel and alignment.
16. Look through the front of the console to insure the strap is wrapping directly over the previous wrap. NOTE: If strap begins to roll off to one side and adjustment must be made or premature wear may occur. If the strap is rolling off an adjustment to the white plastic guide roller can be made. There are two bolts on the bracket that holds the white roller that mount the roller to the console. Loosen those two bolts. Directly underneath the white roller are two bolt heads sticking out of the bottom of the console. These bolts can be turned in or out twisting the roller bracket either left or right steering the spring strap in the correct direction. Be sure to tighten down all nuts and bolts after adjustments are made.
