| Summary | Replacing the wireless on a TSI Gen 2 | | | | |
| Products Affected | TSI Gen 2 | | | | |
| Author | Mike Burzlaff | Issue Date | 9/1/16 | Status | Active |

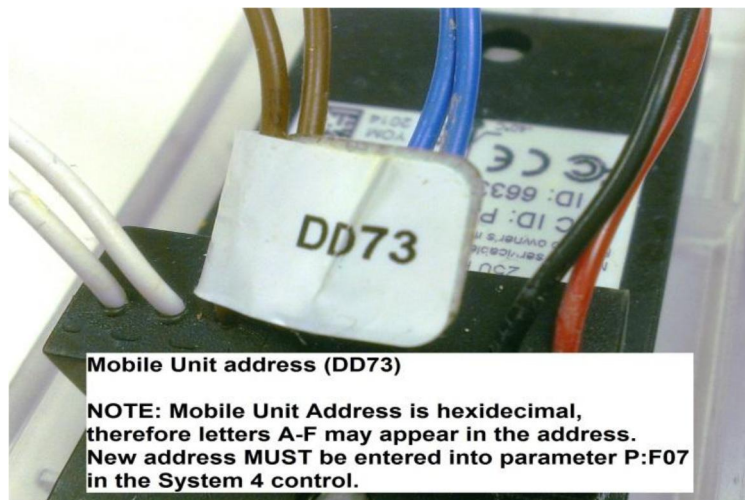
7. The new color code is as follows.
  - Red** is battery positive (+) The brown from the battery and brown from the impact sensor connect to the red wire.

8. Connect the wires as described above with the new wire colors. The brown wires **MUST** be capped separately or a F822 fault will occur.
9. When the connections are completed, neatly place all wires back into the bottom bar. Remove the "Lock out/Tag out" and re-apply power to the controller. Press and hold the STOP/RESET button to clear any faults that may be displayed.
10. The new mobile address must be programmed into parameter (P.F07) The address is no longer imprinted on the unit. The mobile unit address is printed on the white sticker attached to the wires.
